Tufnol for Surgical Instrument Handles – Technical Notes & Case Study

CASE STUDY / Example of SRBF Handle failure: (See photos on next page)

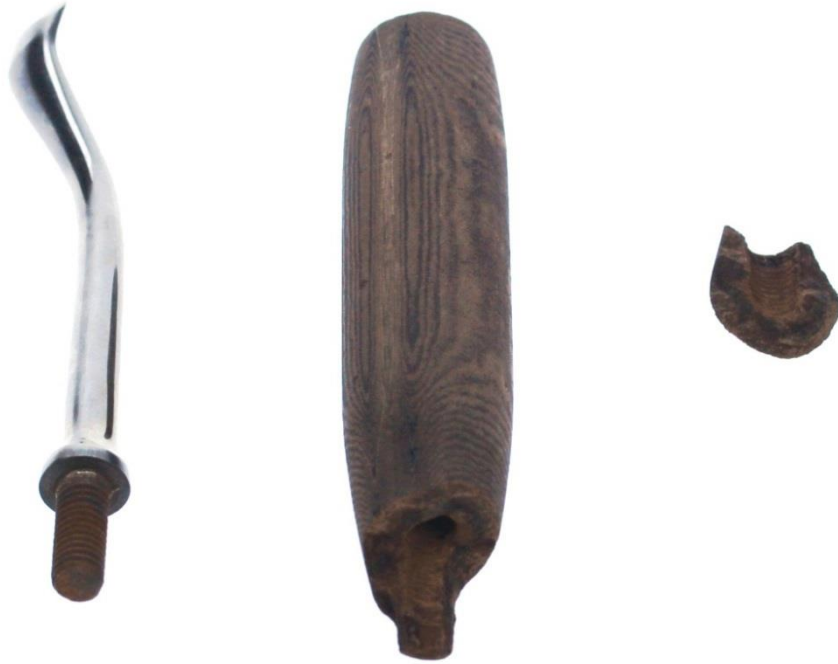
The Capener Gouge featured in this case study was submitted to Bolton Surgical for technical evaluation and comment (It was not returned under complaint) as a result of failure during use. On this occasion no patient harm was incurred but nevertheless, this illustrates a potential risk if the condition of aging instrument handles and their fitments are neglected. The instrument was reported to be over 15 years old. The gouge was not made by Bolton Surgical but that is not to say that a Bolton Surgical equivalent product would not have suffered the same fate under the same circumstances.

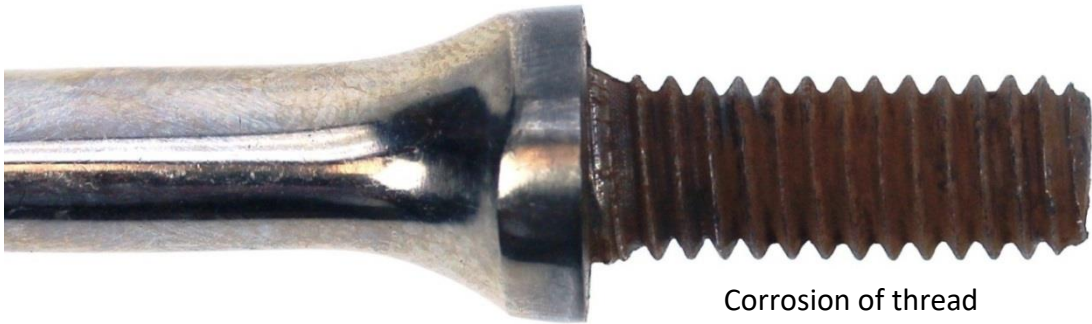
1. The handle is manufactured from 'Tufnol' or an alternative Synthetic Resin Bonded Fabric.
2. The general blade passivation was still intact on exposed surfaces but heavy corrosion is present on the threaded end.
3. There is no evidence of any sealing compounds remaining in the threaded blade to handle joint, this could be because the thread was not sealed originally or that the sealing compound has degraded with continual use.
4. Rust in the blade thread is undoubtedly the result of ingress and entrapment of water, saline or maybe RO water that has given rise to chloride or crevice corrosion.

Corrosion of thread caused by trapped fluids

- 5.4. Solutions ingressed as above become largely trapped between the handle and blade and chemically destroy the passive surface of the stainless steel thread resulting in corrosion. As the iron in the steel corrodes, its volume increases by up to 10 times resulting in significant bursting pressure being applied to the inside of the handle, causing stress cracking of the handle if the rust is not released.

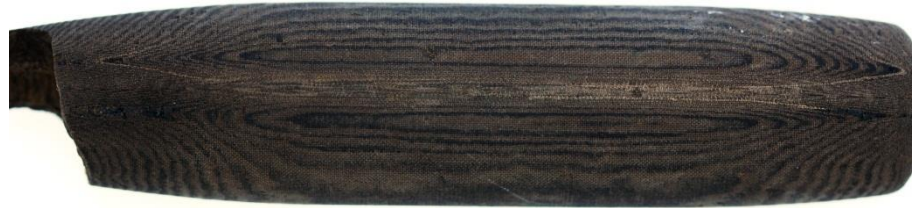
Thread in handle almost totally decomposed and fragmented

- 5.2. The thermal expansion of the 'Tufnol' handle is about 65% greater than that of the stainless steel blade resulting in the handle expanding away from the blade during heating causing movement and therefore wear and loosening of the threaded joint over time. This movement also causes sealing adhesives to be repeatedly put under tensile stress and is likely to be a contributing factor (along with high compressive impact stresses induced during normal use) causing gradual loss of any sealing compound originally used to seal the thread.
